**Coal Combustion Waste Impoundment  
Round 7 - Dam Assessment Report**

***Black Dog Power Station***

***Surface Impoundments***

**April 2011**

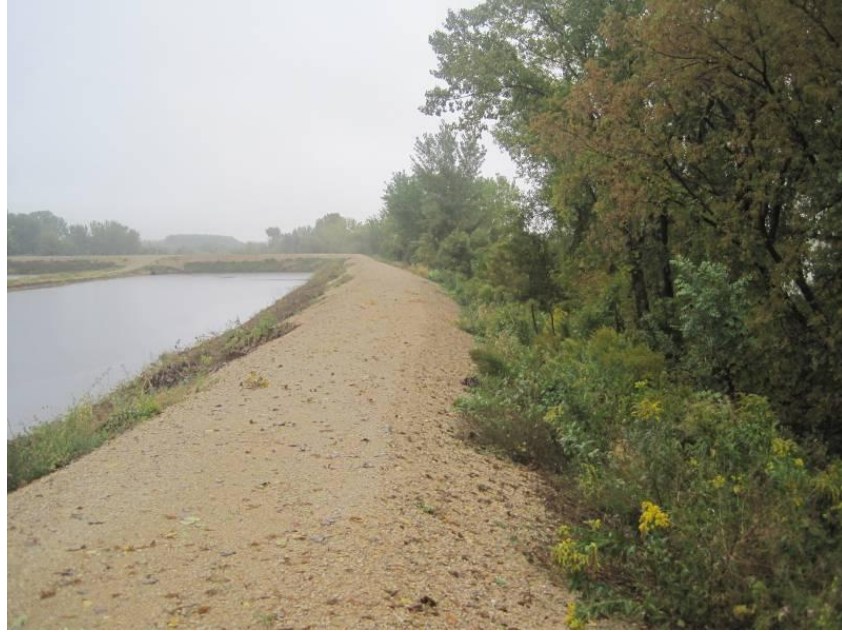
The crest of the embankment had no signs of significant depressions, tension cracks or other indications of settlement or shear failure. Figure 5.2.1-1 and Figure 5.2.1-2 show the typical crest condition of the embankment along Pond 3 and Pond 4, respectively.

**Figure 5.2.1-1:** Crest of embankment looking east; Pond 3 is to the left and Black Dog Lake is to the right; Crest also serves as the flood control berm; Note flood control berm wrapping to the left in the distance around Ponds 3, 2, and 1

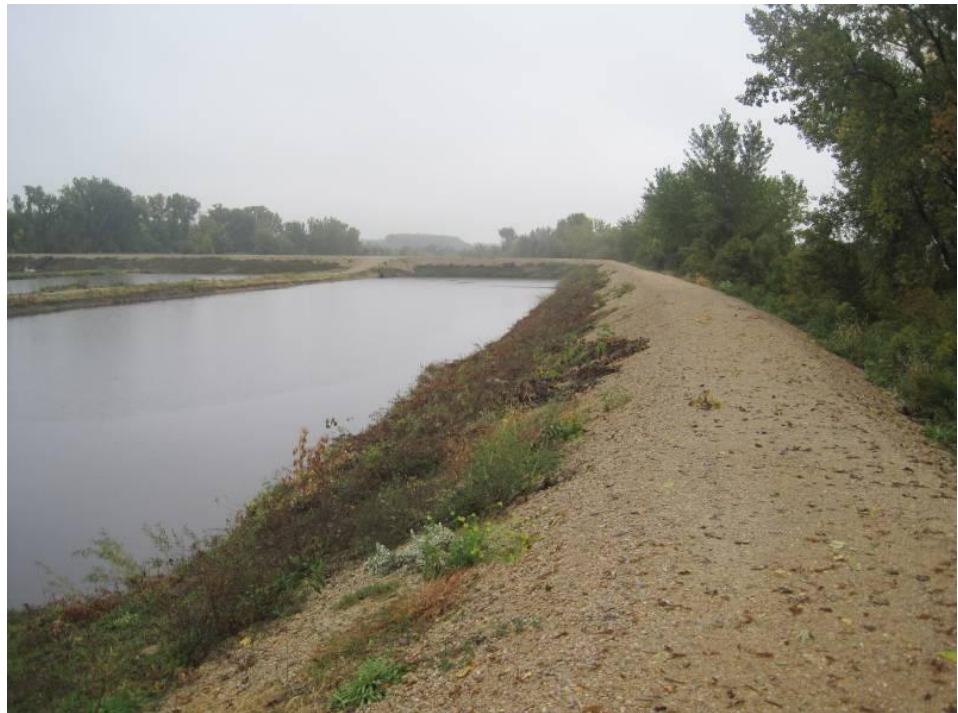
The inside slope of the embankment, including all groins, had a coverage of mixed grasses/weeds and gravel adjacent to Pond 3, and mixed grasses/weeds adjacent to Pond 4. There were no observed scarps, sloughs, bulging, cracks, depressions or other indications of slope instability. Figures 5.2.2-1 and 5.2.2-2 show a representative section of the embankment looking east and west from Pond 3 and Pond 4, respectively.

**Figure 5.2.2-1:** Inside slope of embankment looking east; Pond 3 is located to the immediate left

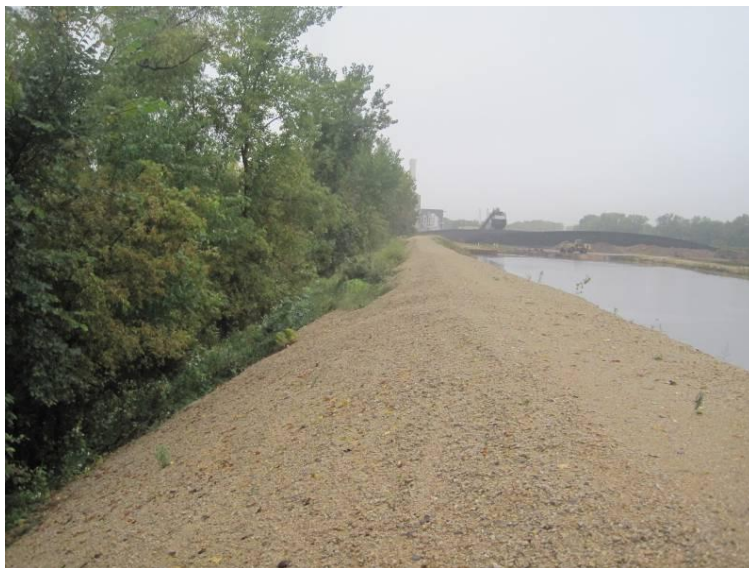
The outside slope of the embankment is vegetated with various species of tall grasses and weeds. The toe of the embankment follows the shoreline of Black Dog Lake where there are trees also growing. Heavy overgrowth along the outside slope of the embankment and toe made close observation of the embankment difficult. Based on what could be observed there were no scarps, sloughs, bulging, cracks, depressions or other indications of slope instability. Figures 5.2.3-1 and 5.2.3-2 show a representative section of the embankment looking west from Pond 3 and Pond 4.

**Figure 5.2.3-1:** Outside slope of embankment to the left looking west;  
Pond 3 is located to the immediate right

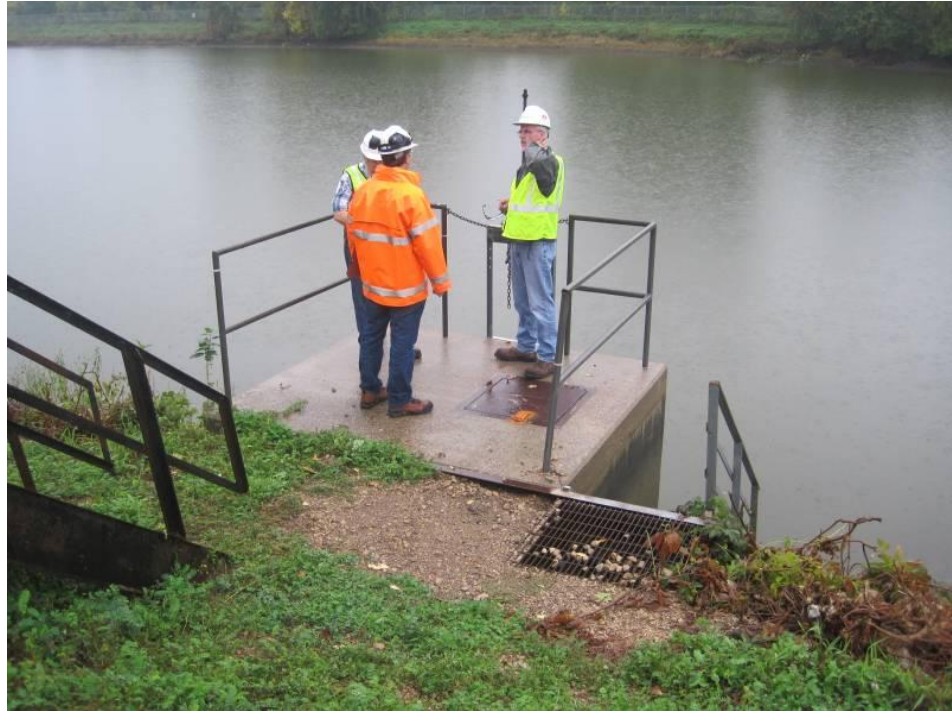
The system of four CCW ponds discharges into Black Dog Lake through a spillway structure located in the south-east corner of Pond 4. The spillway was observed to be working properly, discharging flow from the pond, and visually appeared to be in satisfactory condition. There were no signs of clogging of the spillway and the water exiting the structure was flowing clear. Figure 5.3.1- 1 shows the spillway overflow structure.

**Figure 5.3.1-1:** Overflow spillway structure looking north across Pond 4 from top of embankment
